Warranty Repair Guidelines

TCWY1250 EN-US

August 2017

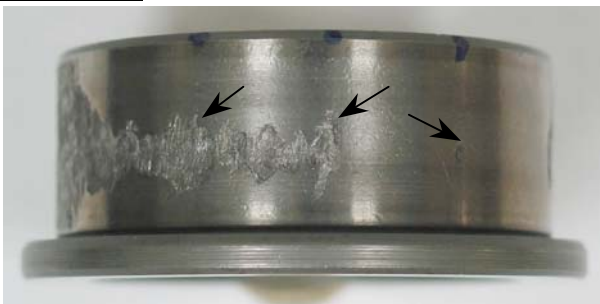
Partially pitted

Repair Guideline - Minor:

- Replace 4 C/S bearings only, gaskets and oil.
- Re-use input bearing, inspect/re-use auxiliary drive gear bearing.
- Auxiliary section to be flushed/inspected only not disassembled.

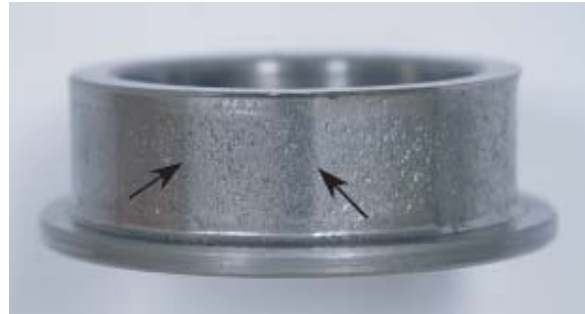
Severally pitted, race worn down

Repair Guideline - Major:

- Replace 4 C/S bearings.
- Replace input shaft bearing.
- Clean/inspect replace auxiliary. drive gear bearing if pitting is found on the races.
- Auxiliary section to be flushed/inspected only not disassembled*.
- Mainshaft should be disassembled and damaged parts replaced.
- The input bushing will generally be damaged and can be replaced if bore in the input shaft is not damaged.

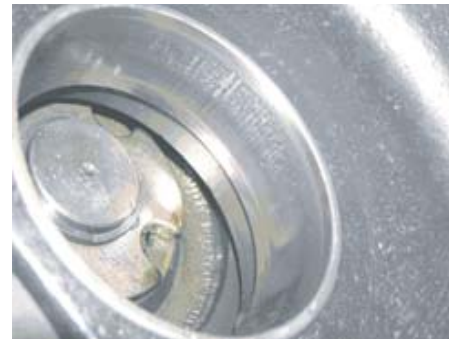
Spalling on races, pitting on rollers

Replace

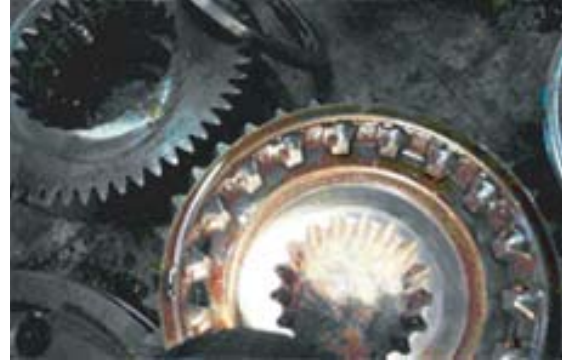
Secondary Damage From Loose Gears

Figure 1: Fretting damage on the auxiliary drive gear clutching teeth.

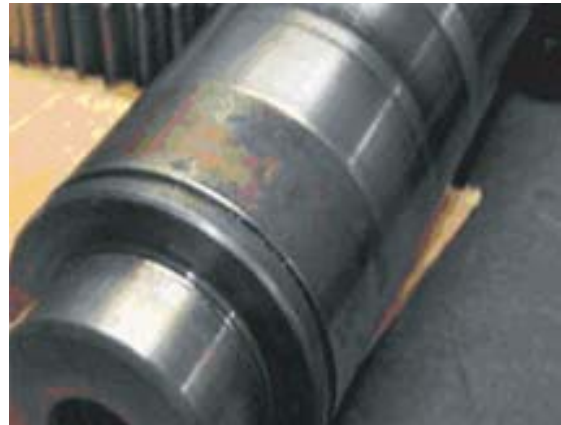
Figure 2: Fretting damage (wear) on countershaft from a loose gear.

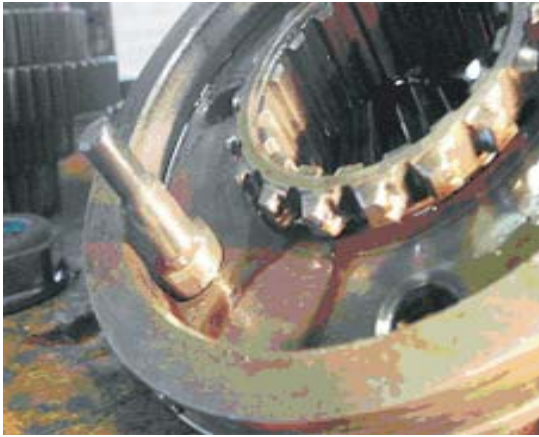
Figure 3: Fretting damage on range clutch on high side.

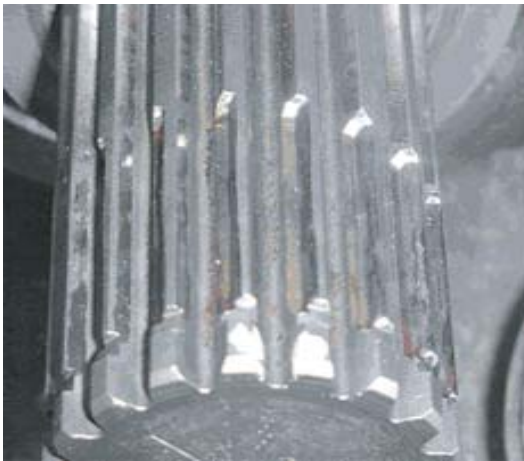
Figure 4: Fretting damage to end of front box mainshaft.

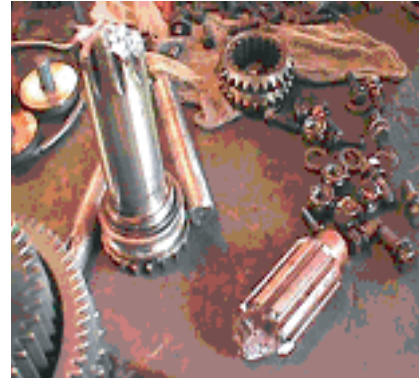
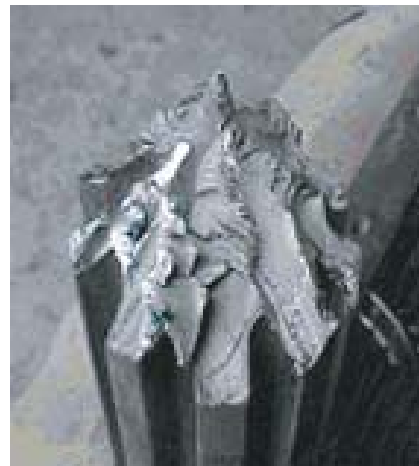
Pictures of non-warrantable failures:

Non-warrantable failure; claim can be sent in through normal warranty for review if requested.

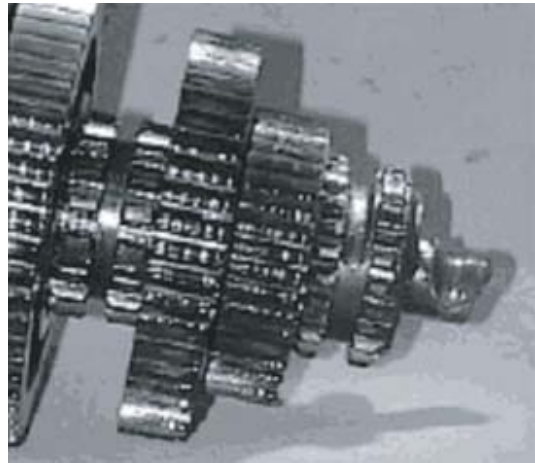
Figure 1: Notice the mainshaft pilot wear bias one side due to centrifugal force.

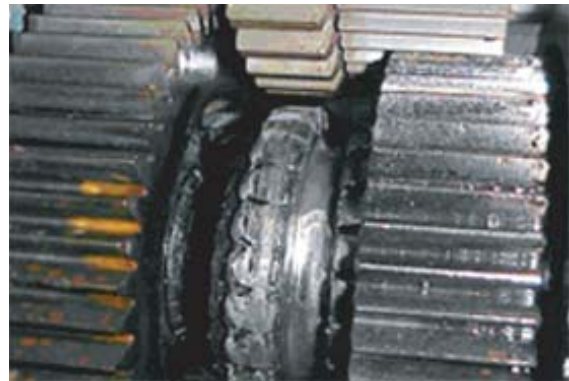
Figure 2: FRO unit overdrive clutch skewed to one side and burned.

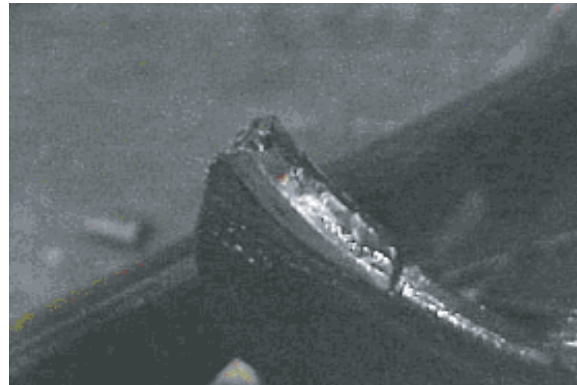
Figure 3: Shift yoke burned and broken off from M/S being skewed.

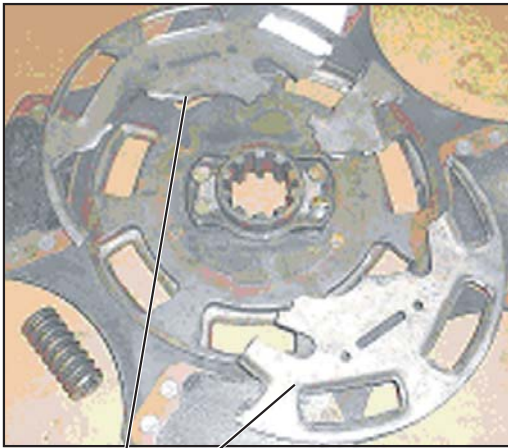
Broken disc damper spring(s).

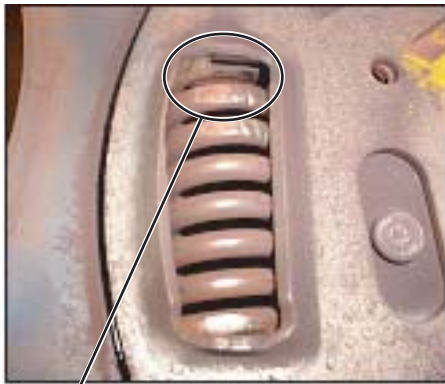
Broken disc damper spring(s).

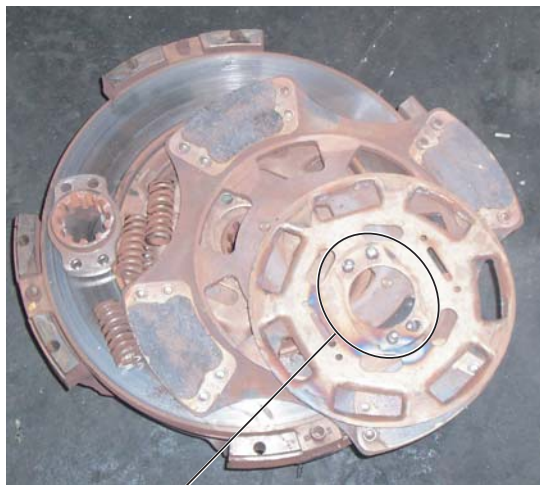
Broken disc damper hub rivets.
