Warranty Repair Guidelines

TCWY1250 EN-US

August 2017

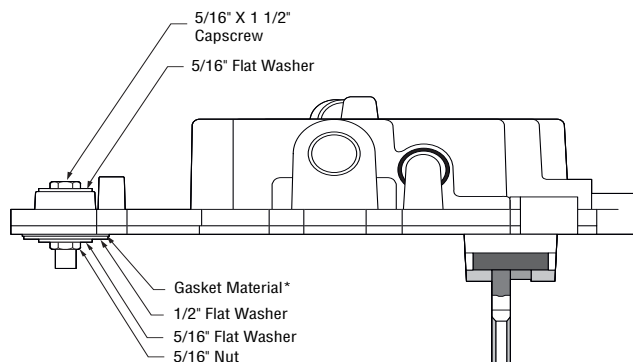
Air Module Isolation

* Gasket material must be used to seal the two holes in the bottom of air module.

With module still mounted, install a 0-100 psi test gauge in each high (H) and low (L) test port on top of the module. Supply a minimum of 90 psi to the module inlet port and operate the range lever between high and low range. Slow response in either direction or a pressure reading outside the 75-85 psi range equals a failed module.

If troubleshooting steps indicate the module is defective or the regulated pressure is out of range (75-85 psi), replace the module as a unit. The module is not a serviceable unit.

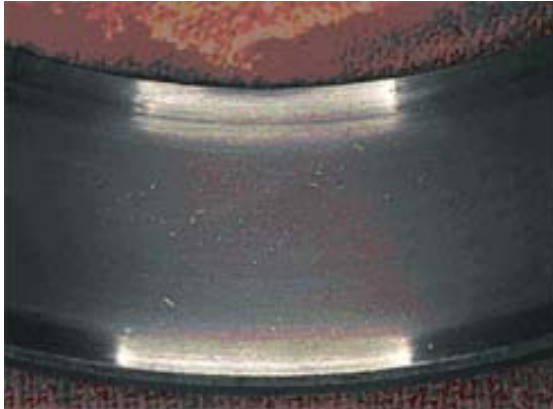
Dull polish, light debris dents, no pitting.

Re-use

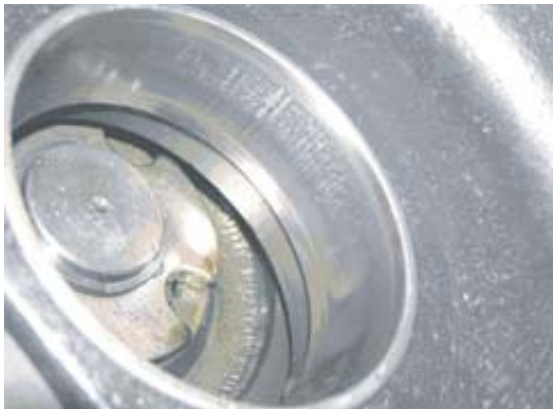
Spalling on races, pitting on rollers

Replace

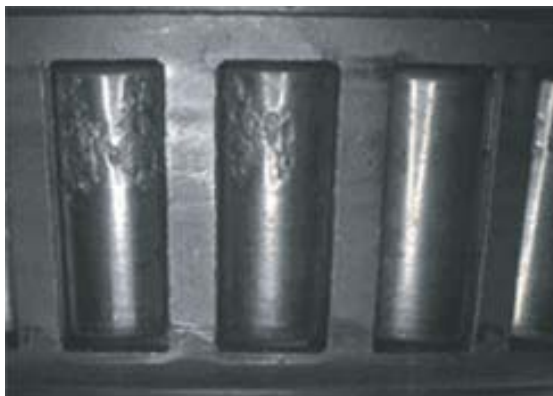
Severally pitted, race worn down

Replace

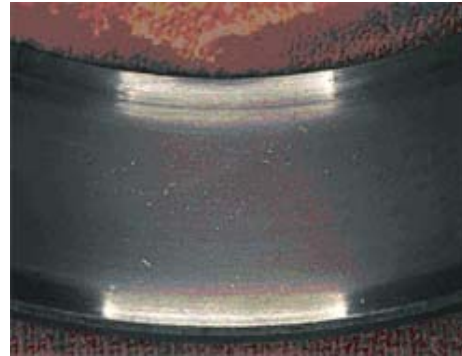
Dull polish, light debris dents, no pitting.

Re-use

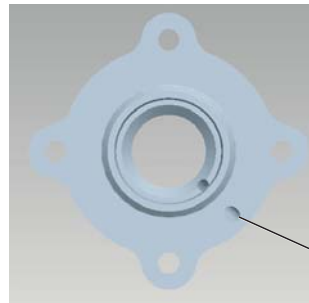
Feed air manually to this port, listen for piston to move in and out.

After T/S of fault code if the technician determines the need to disassemble, try shop air to the cylinder housing port manually before disassembly, listening to determine if the piston moves in and out. Once the need to visually inspect the splitter cylinder is determined the tech may replace the o-rings and re-lube the cylinder walls with the silicone lubricant provided in the kit.

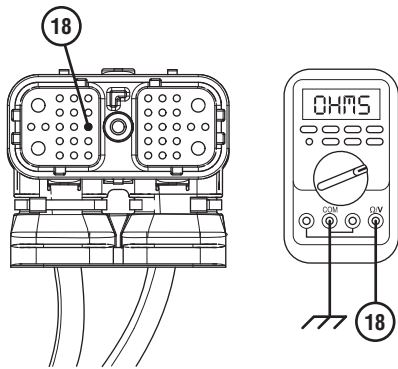
1. Key off.
2. Disconnect 38-Way Transmission Harness Connector from the TECU.
3. Inspect 38-Way Connector body for damage and bent, spread, corroded or loose terminals.
4. Measure resistance between 38-Way Transmission Harness Connector Pin 18 and ground. Record reading(s) in table.

5. Compare reading(s) in table.
 - If connector is damaged, replace Transmission Harness. Go to **Step V.**
 - If readings are in range, go to **Step E.**
 - If readings are out of range, replace Transmission Harness. Go to **Step V.**

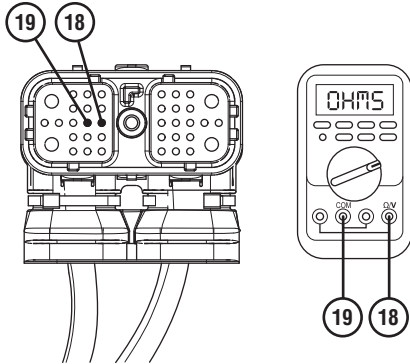
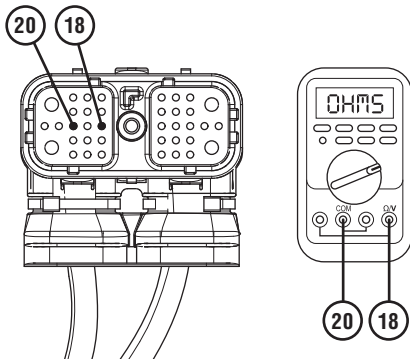
1. Key off.
2. Measure resistance between 38-Way Transmission Harness Connector Pin 18 and Pin 19. Record reading(s) in table.

3. Measure resistance between 38-Way Transmission Harness Connector Pin 18 and Pin 20. Record reading(s) in table.

4. Compare reading(s) in table.
 - If all readings are in range, replace transmission harness.
 - If either reading is out of range, go to **Step F.**

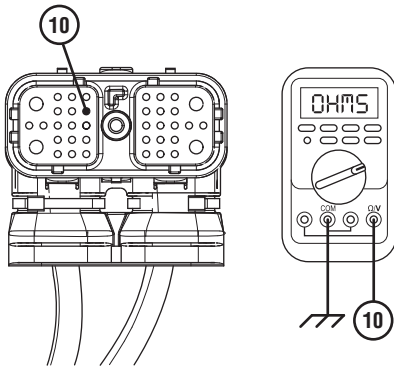
1. Key off.
2. Disconnect 38-Way Transmission Harness Connector from the TECU.
3. Inspect 38-Way Connector body for damage and bent, spread, corroded or loose terminals.
4. Measure resistance between 38-Way Transmission Harness Connector Pin 10 and ground. Record reading(s) in table.

5. Compare reading(s) in table.
 - If connector is damaged, replace Transmission Harness. Go to **Step V.**
 - If readings are in range, go to **Step E.**
 - If readings are out of range, replace Transmission Harness. Go to **Step V.**

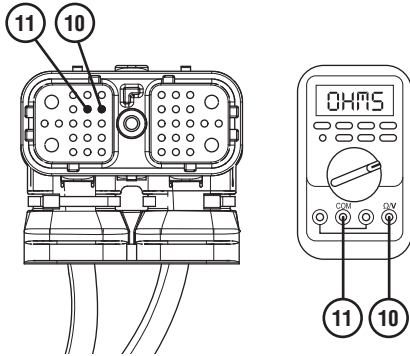
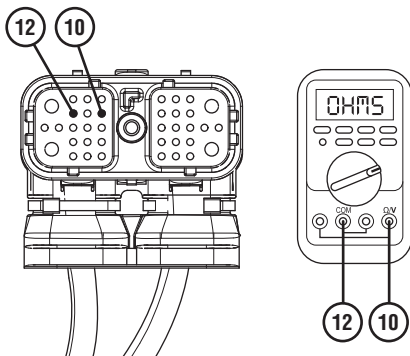
1. Key off.
2. Measure resistance between 38-Way Transmission Harness Connector Pin 10 and Pin 11. Record reading(s) in table.

3. Measure resistance between 38-Way Transmission Harness Connector Pin 10 and Pin 12. Record reading(s) in table.

4. Compare reading(s) in table.
 - If all readings are in range, replace Transmission Harness.
 - If either reading is out of range, go to **Step F**.

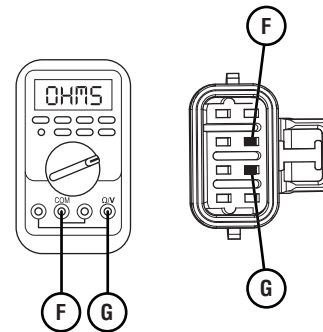
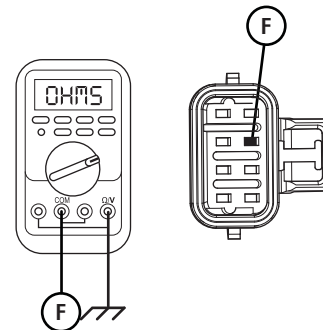
4. Measure resistance between 8-Way Connector Pin F and Pin G. Record reading(s) in table based on configuration.

5. Measure resistance between 8-Way ECA Connector Pin F to ground. Record reading(s) in table.

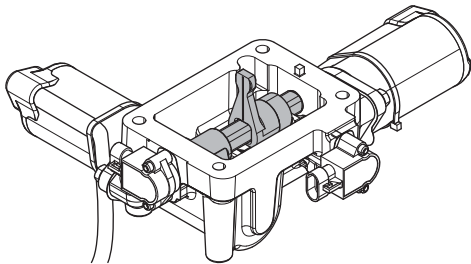
Purpose: Inspect condition of X-Y Shifter internal components.

1. Key off.
2. Remove the X-Y Shifter.
3. Inspect condition of the X-Y Shift Finger and Cross Shaft for damage or wear.

4. Inspect the X-Y Shifter ball screw for signs of coolant contamination.
